Utilizing ScaleBlaster to Reduce Lime Scale Build-up in an Industrial Wastewater Treatment Plant

Documented by
The Village of Sauget Physical/Chemical Plant
May, 2015

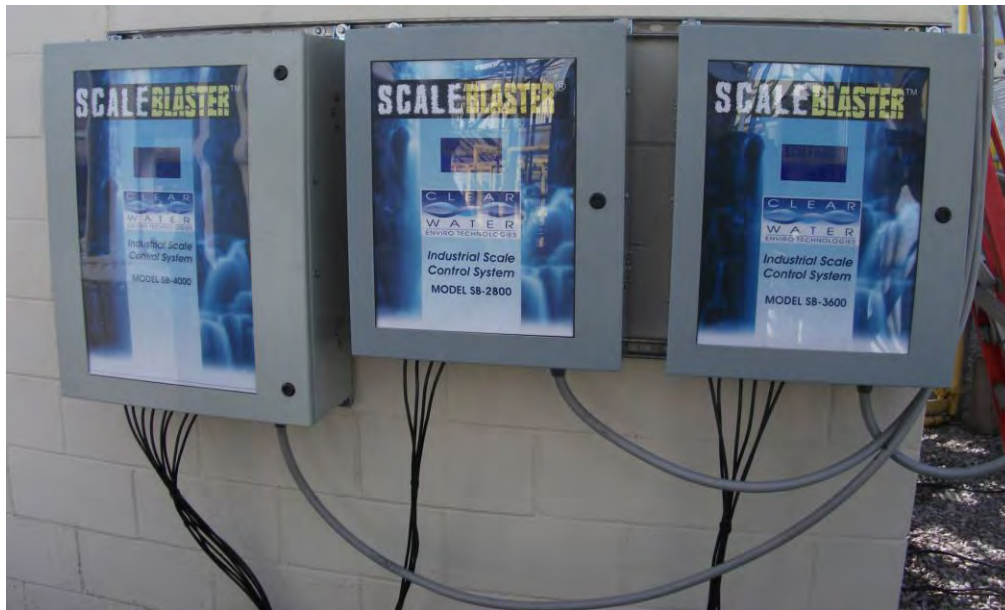
An SB-2800, SB-3600 and SB-4000 was installed on the main waterline at the Village of Sauget water treatment plant.

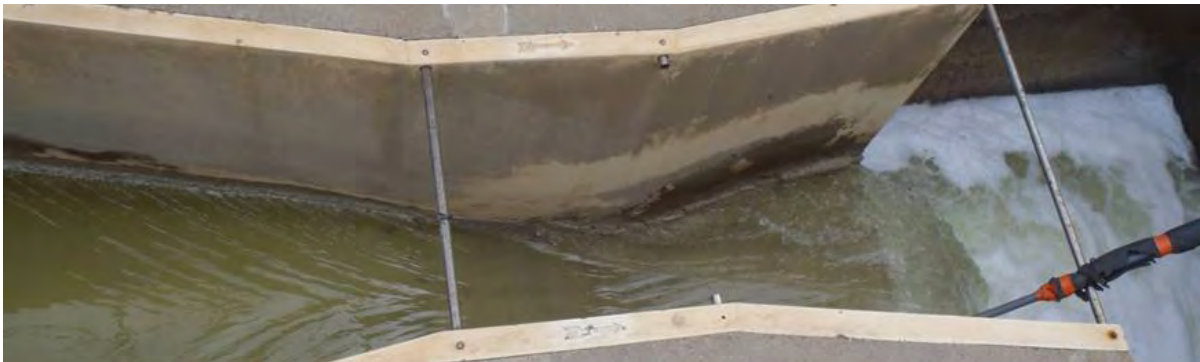
Photo 1: Effluent Flume taken January 31, 2012

Visual observations made throughout the case study period while the PChem plant equipment was in service were not always conclusive. Due to the murkiness of the water and the flow characteristics, it was difficult to determine an accurate measure of lime scale buildup. This is apparent in [Photos 1 and 2 as seen below](#). These are photographs of the effluent flume. [Photo 1](#) was taken just prior to the installation of the **ScaleBlaster** units. [Photo 2](#) was taken more than three years after the installation. The scale appears to be thicker in [Photo 1](#), but it is difficult to judge. [Photos 3 and 4 \(on the next page\)](#) were taken before and after the case study period of a pile of sand/scale just after the final neutralizer chamber. As can be seen from the photographs, the pile of scale and sand is no longer above the surface of the water.

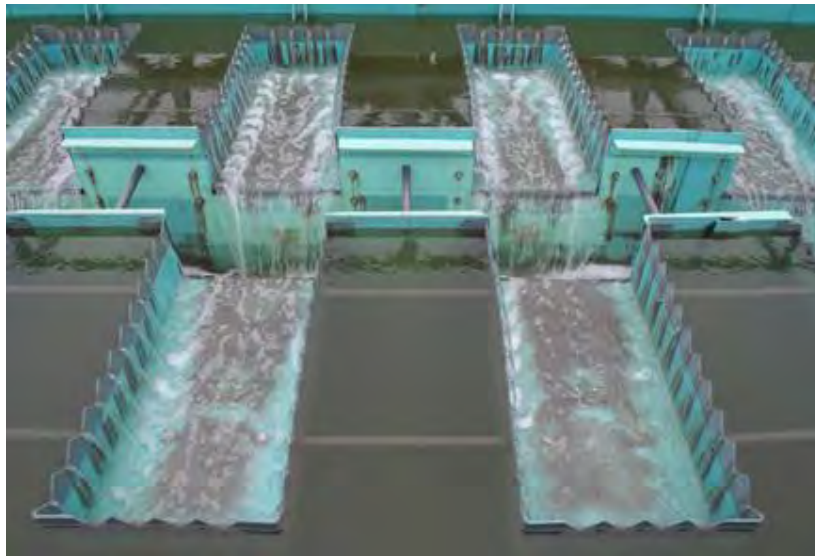
Photo 5: Clarifier Weirs taken November 23, 2011

The main areas of continuous observation that provided conclusive results were the clarifier weirs. Prior to installing the **ScaleBlaster** units, PChem cleaned the clarifier weirs and made weekly observations of the scale buildup for a month before they were cleaned again. These results can be seen in [Photos 5 through 7](#), *below and on the next page*. [Photo 8 \(next page\)](#) is a photograph taken after the case study period. The weirs in this photo have not been cleaned in more than five and a half months. There is a thin layer of lime scale buildup, but there are no chunks of buildup as in the photos taken prior to the **ScaleBlaster** install. Currently, the clarifier weirs are cleaned one to two times per year. Prior to the installation of the **ScaleBlaster** units, these weirs were cleaned biweekly. As can be seen in [Photos 9 and 10, \(on page 9\)](#) the flocculation chamber chains continue to build up some scale. Based on observations, the buildup appears to occur more slowly and is not as thick as it was prior to the **ScaleBlaster** install.

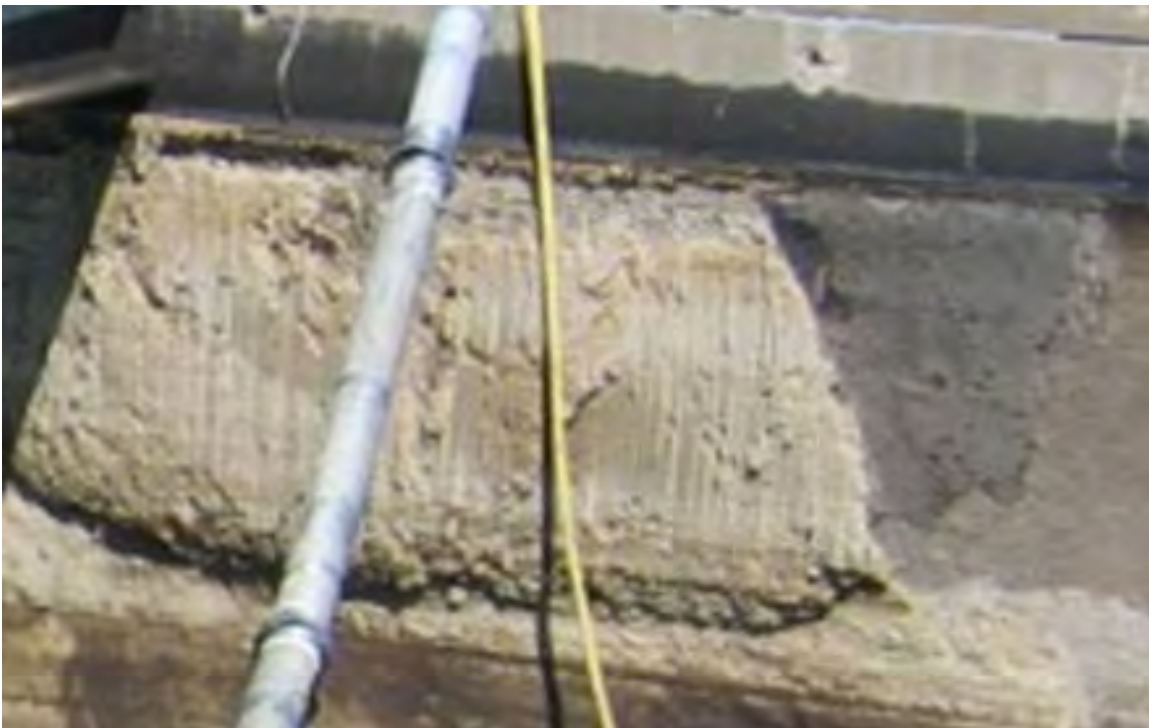
**Photo 11: Clarifier Wall taken April 2, 2007
(Clarifier in service for 6 months. Part of wall already scraped)**

Pchem has been able to drain several areas of the plant to observe the scale buildup and clean where necessary. Both clarifiers have been taken out of service during the case study, the main channel has been taken out of service several times, and the final neutralizer chamber was taken out of service for inspection on March 27, 2015. The clarifiers are generally taken out of service for maintenance at least once a year. Most recently, in April of 2015, the South clarifier was taken out of service to inspect the sludge pits after having been in service for approximately six months. As can be seen in [Photo 13, \(next page\)](#) there was only a thin film of scale buildup on the walls of the clarifier. This is compared to the thick buildup that can be seen in the [Photo 11 \(below\)](#) from the clarifier cleanout in 2007. This clarifier had been in service for approximately six months also. As can be seen in the photograph, the scale buildup is much thicker. Part of the clarifier wall had already been scraped when this photograph was taken in 2007. [Photo 12 \(next page\)](#) was taken in 2012 of the North clarifier after it had been in service for more than a year. The clarifier was taken out of service after the installation of **ScaleBlaster**. As can be seen in the photograph, some of the thick scale layer had fallen off of the wall. There was also a big difference in the amount of buildup in the flocculation chambers in the clarifiers. While there is some buildup on the wall, there is little to no buildup on the flocculation paddles. [Photos 14 and 15 \(page 12\)](#) show the scale buildup in the flocculation chambers prior to the **ScaleBlaster** installation, as compared to [Photos 16 and 17 \(page 13\)](#) which were taken at the end of the case study period.

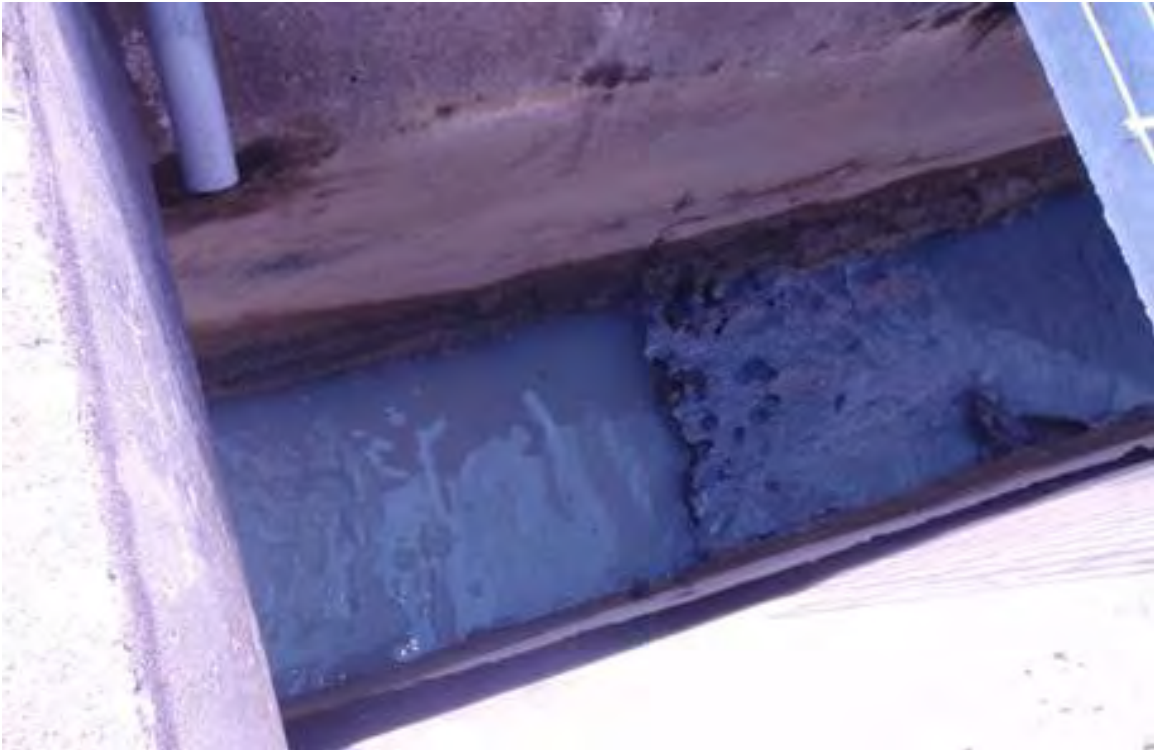
Photo 18: Main Channel taken October 13, 2010

The main channel between the neutralizer chambers and the clarifiers continues to collect scale. There are few photos of the main channel prior to the **ScaleBlaster** installation. [Photo 18 \(below\)](#) was taken in 2010. It is difficult to see the level of scale buildup in this photograph. The channel was cleaned in 2012, 2013, and partially in 2014 for a gate installation. The buildup between each of these cleanouts was consistent with what PChem had seen in the past, although it could be slightly less. It is difficult to get a good measurement of the amount of scale due to the pattern in which the scale forms. [Photos 19, 20 and 21 \(pages 15 and 16\)](#) are photographs taken during each of these cleanings. PChem and **ScaleBlaster** have discussed possible solutions to this problem area. In response to suggestions from **ScaleBlaster** and for overall process improvement, PChem installed gates at the beginning of the main channels in order to increase flow velocity through the channels by using only a single channel when flows permit. This will in turn improve the effectiveness of the **ScaleBlaster** units in this area.

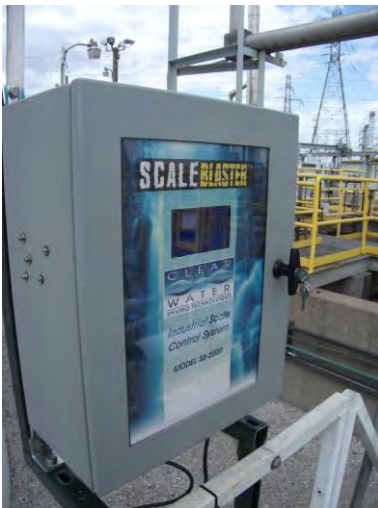
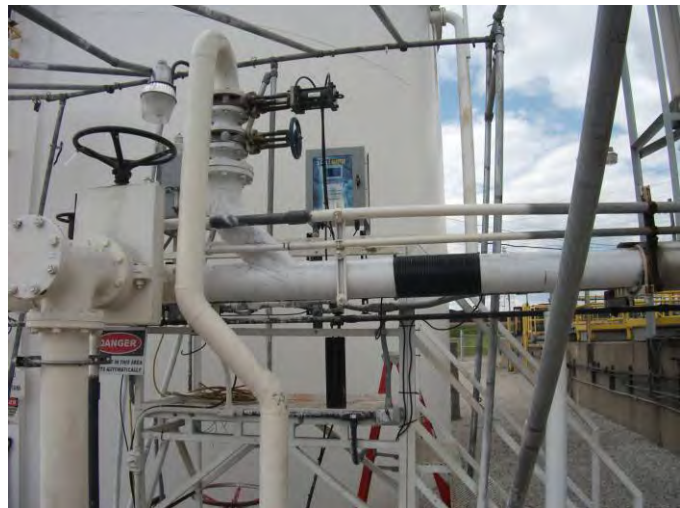
An SB-2000 was installed on the lime slurry (injection) line

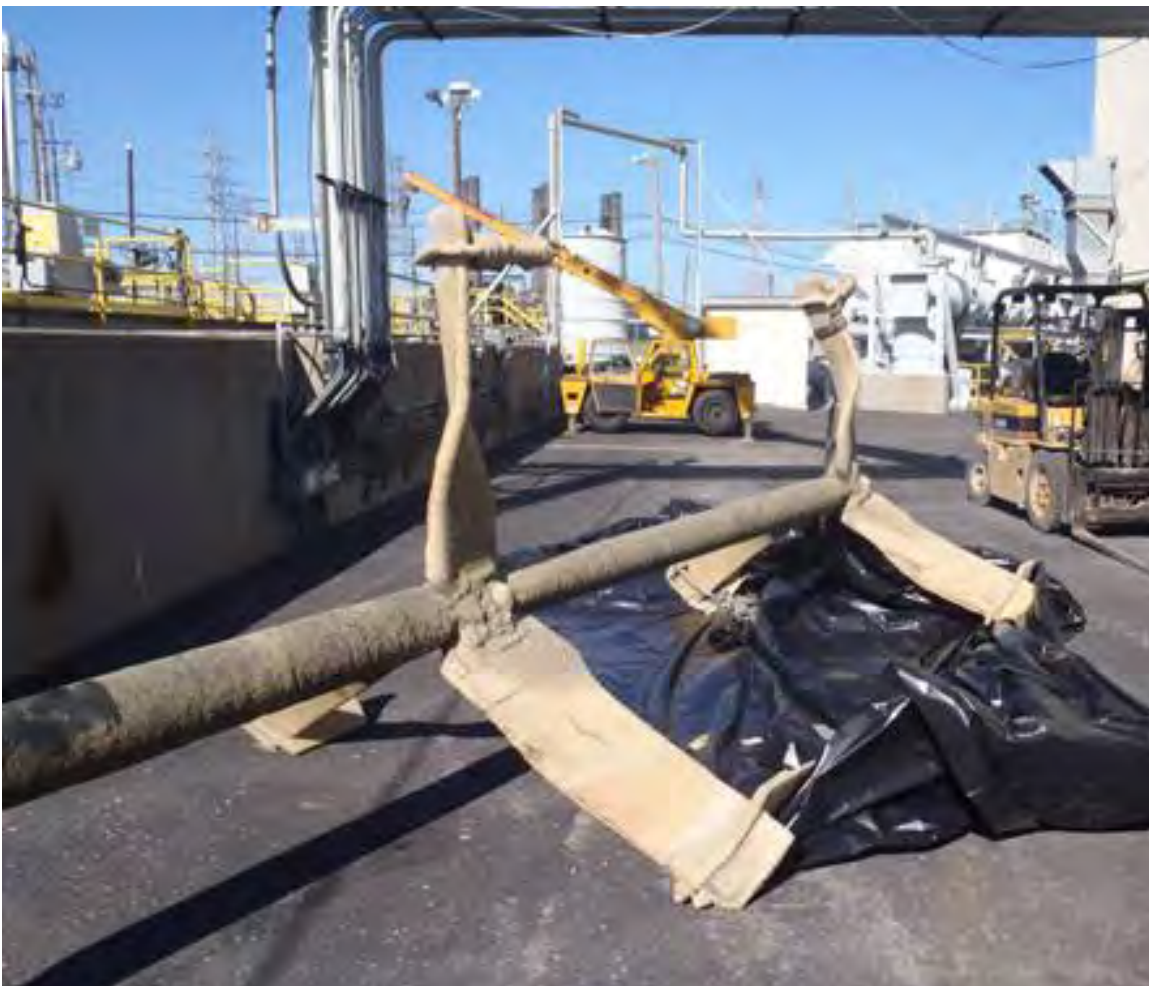
Photo 22: Neutralizer Agitator taken February 22, 2012

The final large piece of equipment that PChem was able to take out of service for inspection was the final neutralizer. Historically, this has been an area that gathers a significant amount of lime scale. PChem had removed the agitator from this neutralizer just prior to the **ScaleBlaster** installation for cleaning. There was a significant amount of buildup on the agitator. [Photo 22 \(below\)](#) shows the scale buildup on the agitator when it was removed in 2012. When the neutralizer chamber was emptied in 2015, the agitator was inspected. It was determined that the agitator did not require cleaning at that time. The buildup was significantly less, and the agitator had not failed due to high amp draw as it had in the past. [Photo 23 \(next page\)](#) shows the buildup on the agitator when it was taken down in 2015. The buildup on the neutralization chamber walls was also drastically reduced. PChem had taken this chamber out of service in 2008 for cleaning and concrete repair. Comparison photos can be found in the appendix. [Photos 24 and 25 \(Page 19\)](#) were taken during the cleaning in 2008, while [Photos 26 and 27 \(page 20\)](#) were taken in 2015 when the chamber was drained for inspection. As can be seen in the photos, there is a drastic difference in the scale buildup on the boards and on the walls. PChem decided not to clean out the neutralization chamber at this time based on the observed buildup. The chamber was immediately put back into service with no cleaning at all.
